# FIRE DOOR SURVEY

## Inspection Report

# SAMPLE FIRE DOOR SURVEY

## Anonymised example report

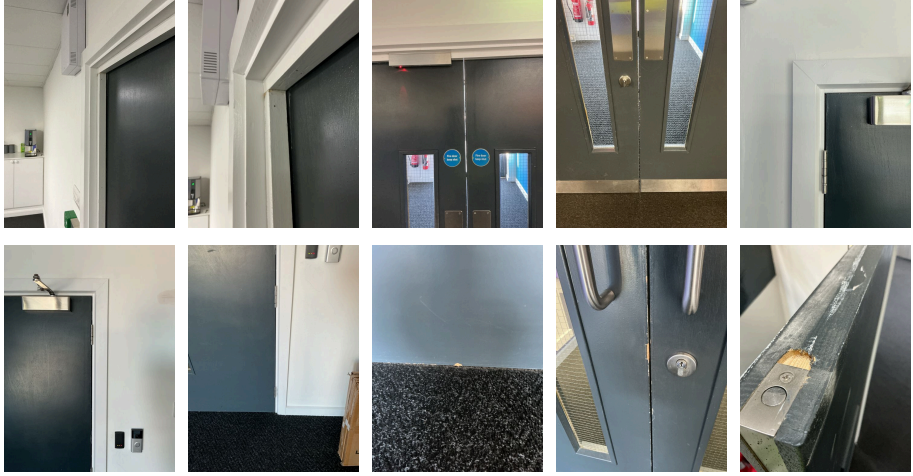
Doorleaf

| Doorleaf | |
|---|---|
| Overall condition - Acceptable? | No <input type="text"/> |
| Edge condition - Acceptable? | No <input type="text"/> |
| Door gaps - Acceptable? | No <input type="text"/> |
| Details (if appropriate) | Double doors - left door leaf damage on bottom of left door. Right door leaf not meeting door stop on hinge side by 5mm.<br>Gaps - Head 1 -4 mm. Hinge side (left and right) 5mm. Centre 5mm. |

| Doorleaf | |
|---|---|
| ART No. | ART 02: Door Leaf Repair (Holes in door) <input type="text"/> |
| | ART 04: Door Gaps Incorrect to Specification <input type="text"/> |

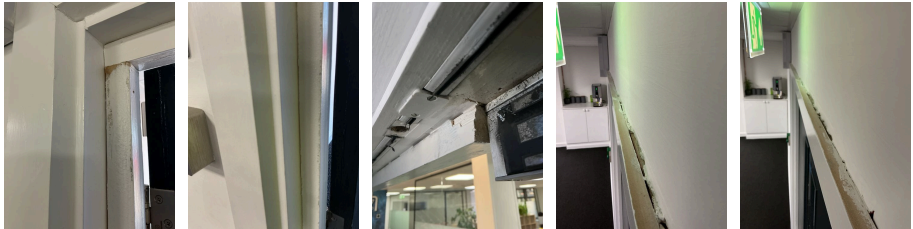
Doorframe

| Overall condition - Acceptable? | No | <input type="radio"/> |
| Securely fixed & correctly installed - Acceptable? | No | <input type="radio"/> |
| Details (if appropriate) | Fire stopping between wall and frame should be checked for compliance. Door stop not firmly fitted and have gaps between stop and frame. | |

| ART No. | ART 20: Door stop Replacement | <input type="radio"/> |

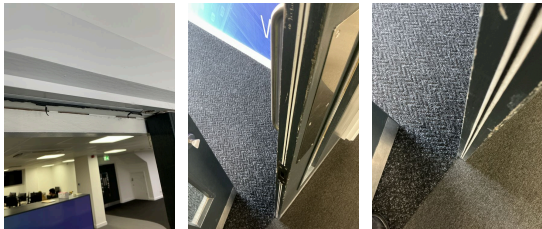
Seals

| Overall condition - Acceptable? | No | <input type="radio"/> |
| Smoke seal condition - Acceptable? | No | <input type="radio"/> |
| Details (if appropriate) | Combined cold smoke and intumescent seal damaged. 15mm on frame and 10mm on leading edge of door leaf. | |

| ART No. | ART 11: WHITE 10mm | <input type="radio"/> |
| | ART 11: WHITE 15mm | <input type="radio"/> |

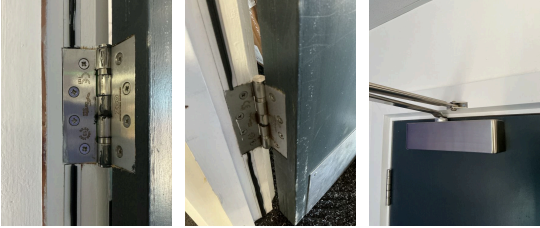
Hardware

| Hinge operation - Acceptable? | No | <input type="radio"/> |

| Door closer - Acceptable? | No | <input type="radio"/> |
| Details (if appropriate) | Door closers are closing too fast and require adjustment. New closer potentially not required. Hinges worn. | |

| ART No. | ART 08: Hinges Dropped or Damaged (Replacement) | <input type="radio"/> |
| | ART 05: Closer Not Operating Correctly (New Closer) | <input type="radio"/> |

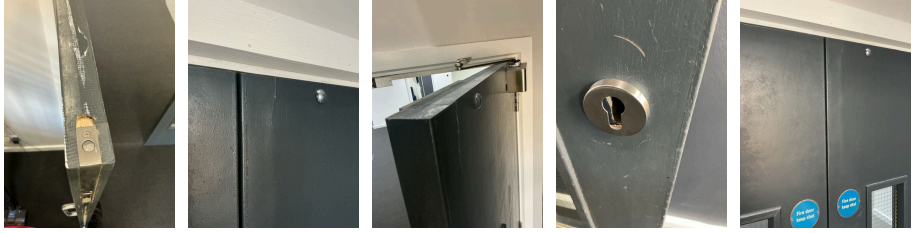
### Doorleaf

| Doorleaf | |
|---|---|
| Overall condition - Acceptable? | No <input type="text"/> |
| Door gaps - Acceptable? | No <input type="text"/> |
| Details (if appropriate) | <p>There appears to be damage to the top of back of the left door leaf which runs from the head down to the top of glazing. This needs further investigation.</p> <p>Gaps - Head 1mm. Right hinge side 1mm. Centre 6mm.</p> |

| Doorleaf | |
|---|---|
| ART No. | ART 02: Door Leaf Repair (Holes in door) <input type="text"/> |
| | ART 04: Door Gaps Incorrect to Specification <input type="text"/> |

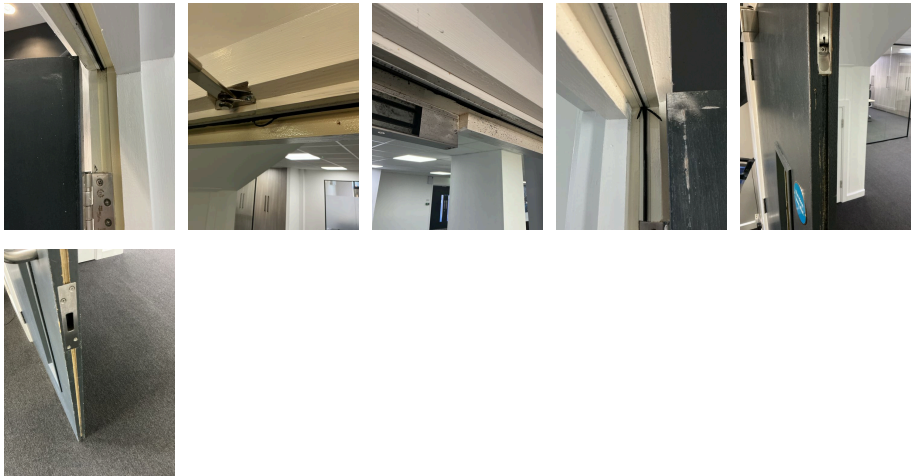
### Seals

| Overall condition - Acceptable? | No | <input type="radio"/> |
| Smoke seal condition - Acceptable? | No | <input type="radio"/> |
| Details (if appropriate) | 15mm on frame. 10mm on door leaf. | |

| ART No. | ART 11: WHITE 10mm | <input type="radio"/> |
| | ART 11: WHITE 15mm | <input type="radio"/> |
